EIELSON AIR FORCE BASE INFILTRATION POND STUDY

Final Technical Report for the Period 24-28 July 1995

EIELSON AIR FORCE BASE, ALASKA, INFILTRATION POND STUDY

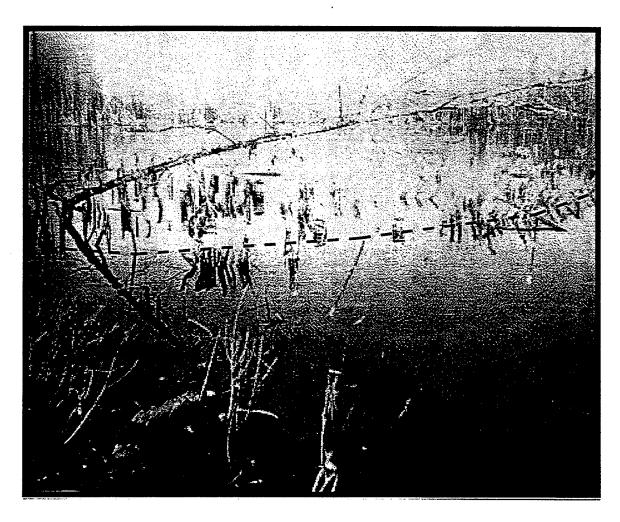
FIGURE A-3
WEST END OF POND, 28 SEP 95

Figure A-1 of Appendix A shows the site location map for the WWTP infiltration basin. It was apparent during the survey that the infiltration pond has become larger than it has historically been. Figure A-2 Shows the approximate shoreline location during the survey. A barbed wire fence around the original perimeter of the pond was almost completely submerged in the water at the time of this survey. WWTP personnel indicated that this fence was entirely above the water in the past. Figures A-3, A-4, and A-5 of Appendix A provide photos taken on 28 September 1995, which show how the water extends beyond the fence line. OEBW believes that the water level was higher during the survey than at the time of these photographs, but does not have pictures for comparison.

Figure A-6 shows the approximate location of sediment samples, and the water depth at each location. The sediment in the infiltration basin was dark green in color and had a mild odor of decaying biological matter. The character and consistency of the sediment was fairly constant throughout the pond, except at locations to where the pond had recently extended. At these locations, OEBW observed significant amounts of coniferous needles, leaves, sticks, and bark or grass, and little collectible sediment. These locations were near the edges of the pond where tree stumps and the surrounding barbed-wire fence protruded from the water. This information, along with past aerial photos, indicate that the pond has not always covered these areas, and that it is, indeed, increasing in size.

(Dotted line shows fence location)

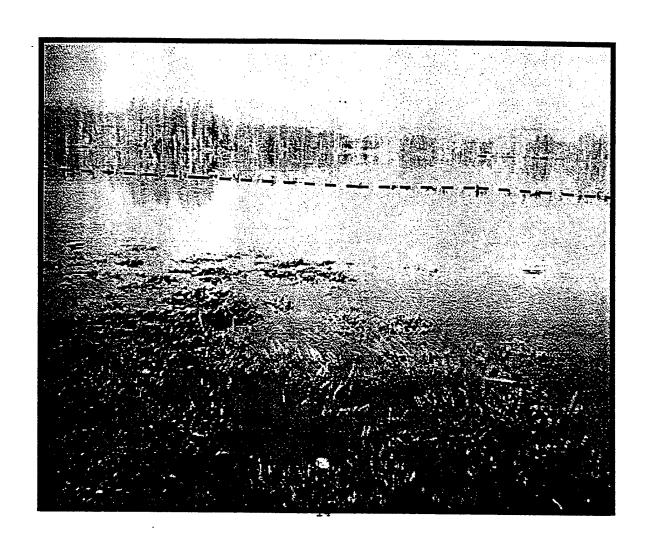
FIGURE A-**5**CENTER OF POND, 28 SEP 95

(Dotted line shows fence location)

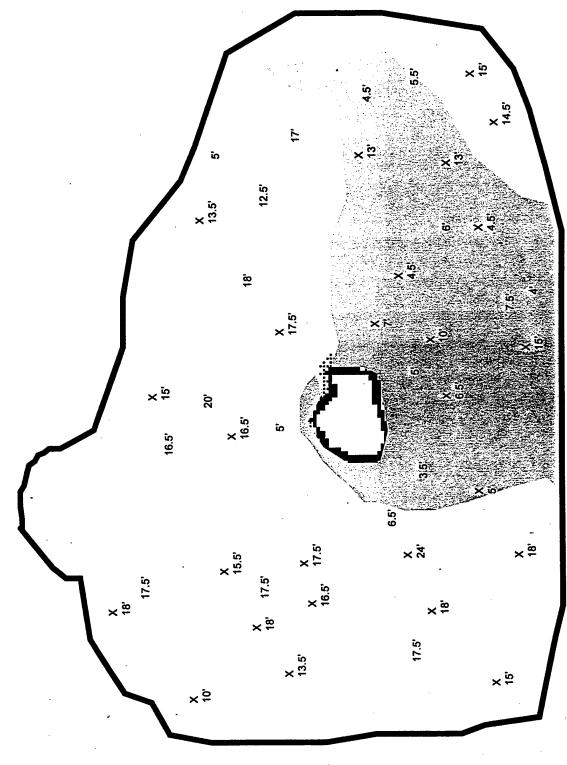
X - Marks Sampling Location

- Indicates Areas with Tree Stumps
